# **PYMATUNING EARTHQUAKE IN PENNSYLVANIA (USA) AND LATE MINOAN CRISIS ON CRETE**

***Yuri Gorokhovich***

***Gary Fleeger***

*1<sup>st</sup> IWA International Symposium on Water and Wastewater Technologies in Ancient Civilizations*

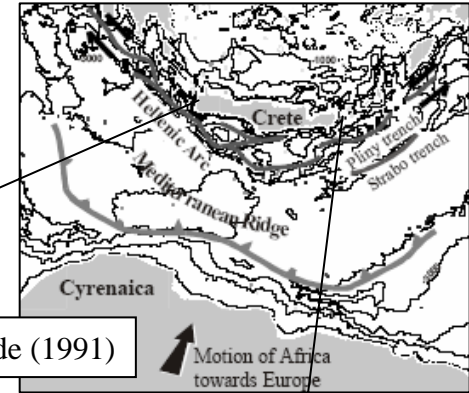
# Seismic Activity on Crete

Density of the earthquakes (based on magnitude value and number of epicenters within 30 km radius) with magnitudes greater than 5 for the past 106 years

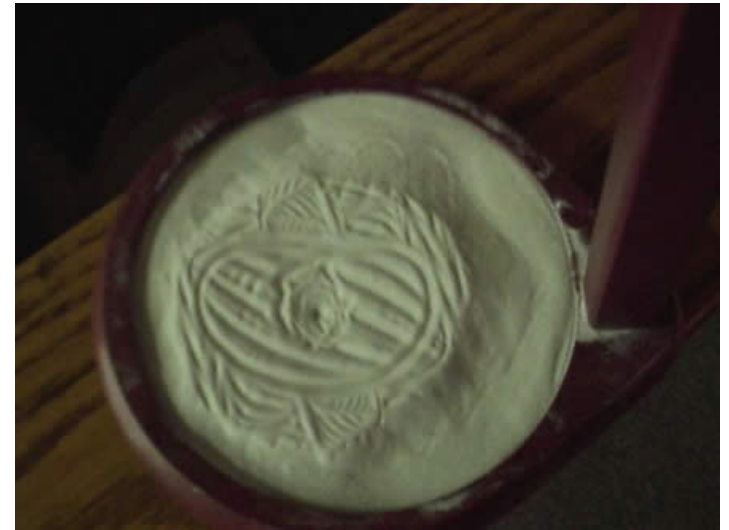
In an earthquake in Pymatuning, PA in 1998 a Foucault's pendulum acting as a seismoscope scribed this incredible work of earthquake art

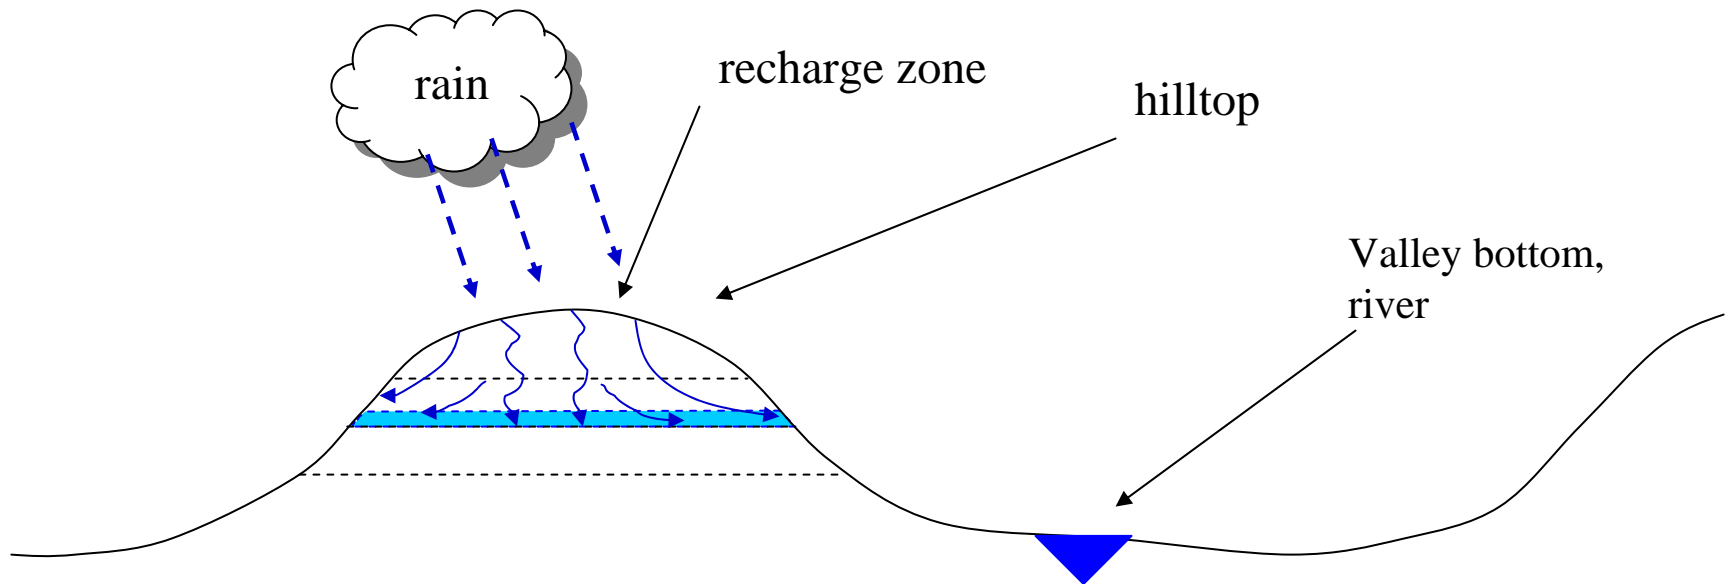
Hydrologic Island Concept: Earthquake shocks can increase the permeability of the aquifer rocks and cause its depletion and lower its level
